**Flood Control Project Maintenance
Levee Inspections**

Maintenance Issue Types Only, Levee Inspection Report By Mile - Fall 2014

Reclamation District No. 2060 Hastings

Waterway	Bank	Unit Miles	Inspection Start/End	Inspector
Unit No. 01 Lindsey Slough	Left	6.97	10/23/2014 10/23/2014	Herman Phillips

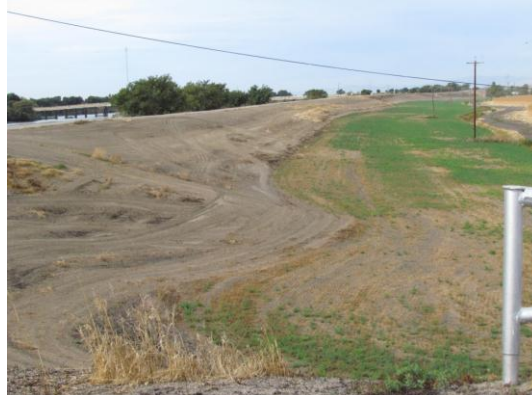
Photo 1 of 1 : FA_2014_RD2060_241_3_20141027_00002.jpg

LM Start	0.00	Rating **	A	Issue No.	3
LM End	6.94	Issue Type +	Ma	Location *	LS
Category	Earthen Levee			GPS Latitude/Longitude	
				Start	End
Item	Vegetation			38.247325 °	38.274841 °
				-121.696303 °	-121.794855 °
DWR ID	DWR_RD2060_01_f_2014_3				
Action/Comments					
Control annual grass and weeds on the levee slopes and easements.

Looking downstream landside levee slope was cleaned and dragged by District. Levee mile 0.00 Unit 1

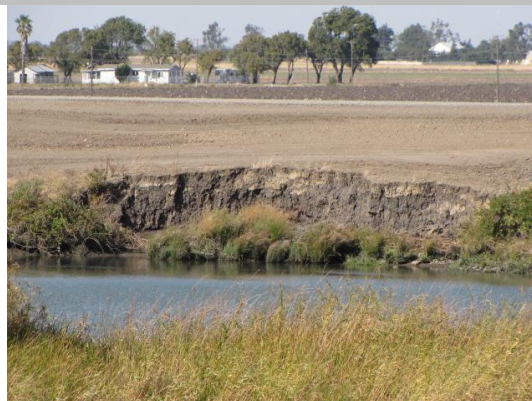
Photo 1 of 1 : FA_2014_RD2060_241_17_20141027_00001.jpg

LM Start	2.40	Rating **	U	Issue No.	17
LM End	2.40	Issue Type +	Ma	Location *	WS
Category	Earthen Levee			GPS Latitude/Longitude	
				Start	End
Item	Erosion / Bank Caving			38.259254 °	38.259254 °
				-121.727257 °	-121.727257 °
DWR ID	DWR_RD2060_01_s_2013_17				
Action/Comments					
Schedule repair of erosion site prior to the next inspection. Inspector Comments: District is aware of the problem, they are scheduling the area to be repaired 2014. During my inspection 10-23-2014 no new repairs has been done at this location. No new photo taken of site.

From RD 536 Looking across channel at RD 2060 Unit 1 erosion site levee mile 2.40 scour hole up to 20' deep and more than 50 feet across. Photo taken 10-08-2013. This erosion site is still active, District has it scheduled for repairs 2014.

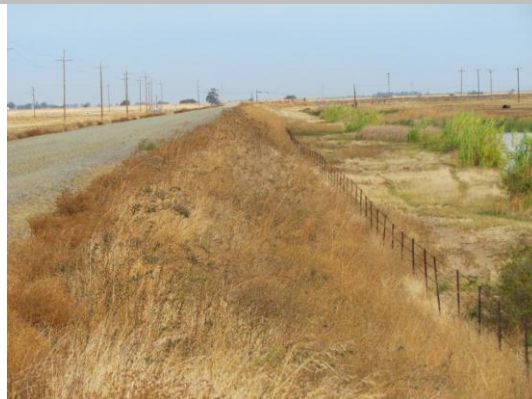
Photo 1 of 1 : FA_2014_RD2060_242_10_20141027_00005.jpg

LM Start	0.00	Rating **	M	Issue No.	10
LM End	3.70	Issue Type +	Ma	Location *	LS
Category	Earthen Levee			GPS Latitude/Longitude	
				Start	End
Item	Vegetation			38.274841 °	38.296651 °
				-121.794855 °	-121.748801 °
DWR ID	DWR_RD2060_02_f_2014_10				
Action/Comments					
Control annual grass and weeds on the levee slopes and easements. Inspector Comments: Looking downstream from landside slope.

Looking downstream from landside of levee slope.

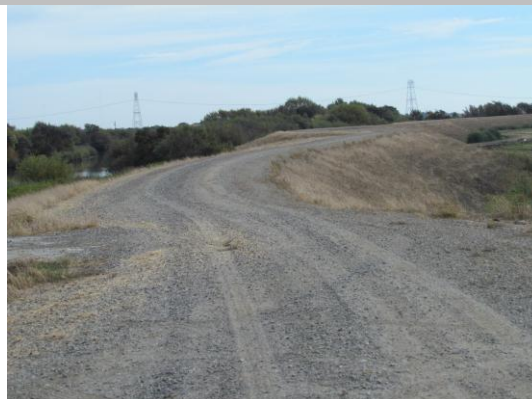
Photo 1 of 1 : FA_2014_RD2060_243_15_20141201_00014.jpg

LM Start	0.00	Rating **	A	Issue No.	15
LM End	0.00	Issue Type +	Ma	Location *	LS
Category	Earthen Levee			GPS Latitude/Longitude	
				Start	End
Item	Vegetation			38.296651 °	38.296651 °
				-121.748800 °	-121.748800 °
DWR ID	DWR_RD2060_03_f_2014_15				
Action/Comments					
Control annual grass and weeds on the levee slopes and easements. Inspector Comments: The District has mowed both levee slopes landward and waterward, starting from levee mile 0.00 heading downstream.

Looking downstream from levee mile 0.00 landside levee slope, grasses has been mowed both landside and waterside.

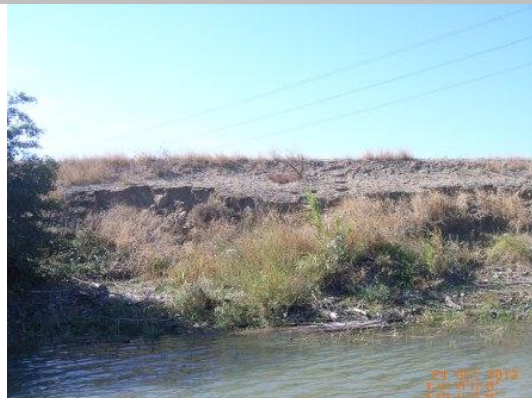
Photo 1 of 1 : FA_2014_RD2060_243_10_20141008_00008.jpg

LM Start	1.51	Rating **	M	Issue No.	10
LM End	1.60	Issue Type +	Ma	Location *	WS
Category	Supplemental			GPS Latitude/Longitude	
				Start	End
Item	USACE Erosion Survey			38.288598 °	38.286051 °
				-121.725184 °	-121.722818 °
DWR ID	DWR_RD2060_03_f_2014_10				
Action/Comments					
Inspector Comments: Site added in 1997 and removed in 2003. 2005 - Put back in the inventory. 2006 - Stone repair at the middle of the site. 2011 - Some rock place at toe in the past year. 2013: Site extended both upstream and downstream to include new erosion pockets. [2013 Site ID: CHS_23-6_R]

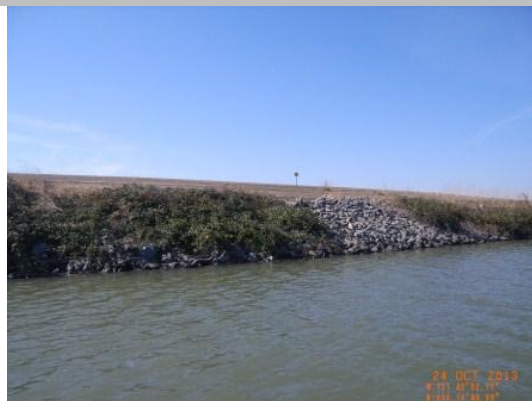
Photo 1 of 1 : FA_2014_RD2060_243_5_20141008_00003.jpg

LM Start	2.34	Rating **	M	Issue No.	5
LM End	2.53	Issue Type +	Ma	Location *	WS
Category	Supplemental			GPS Latitude/Longitude	
				Start	End
Item	USACE Erosion Survey			38.280356 °	38.278214 °
				-121.714697 °	-121.712857 °
DWR ID	DWR_RD2060_03_f_2014_5				
Action/Comments					
Inspector Comments: 2008 - Small scour pockets and mid-slope wave wash. 2010 - More vegetation growth, could be fixed through maintenance. 2011 - Site extended downstream and new erosion. 2013: No observed changes. [2013 Site ID: CHS_22-6_R]

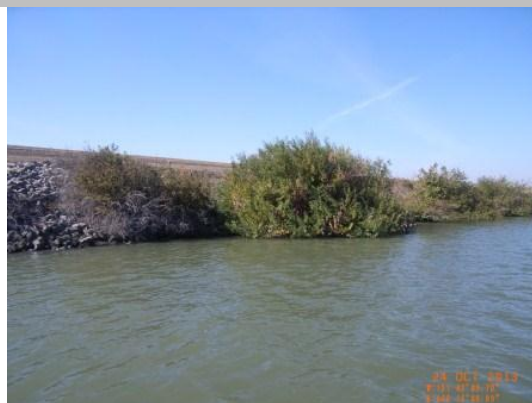
Photo 1 of 1 : FA_2014_RD2060_243_4_20141008_00002.jpg

LM Start	2.54	Rating **	M	Issue No.	4
LM End	2.58	Issue Type +	Ma	Location *	WS
Category	Supplemental			GPS Latitude/Longitude	
				Start	End
Item	USACE Erosion Survey			38.278109 °	38.277754 °
				-121.712671 °	-121.712144 °
DWR ID	DWR_RD2060_03_f_2014_4				
Action/Comments					
Inspector Comments: 2013: Erosion pockets into the levee toe. [2013 Site ID: CHS_22-5_R]

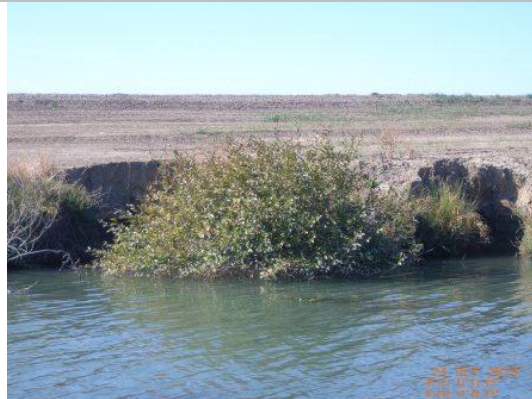
Photo 1 of 1 : FA_2014_RD2060_243_1_20141008_00001.jpg

LM Start	3.67	Rating **	M	Issue No.	1
LM End	4.08	Issue Type +	Ma	Location *	WS
Category	Supplemental			GPS Latitude/Longitude	
				Start	End
Item	USACE Erosion Survey			38.264585 °	38.260593 °
				-121.698868 °	-121.696403 °
DWR ID	DWR_RD2060_03_f_2014_1				
Action/Comments					
Inspector Comments: 2011 - Several pockets of erosion from rotational failure and slumping toe. 2013: Site extended downstream to include new erosion pockets. [2013 Site ID: CHS_21-1_R]
